Technical Report CHL-97-5
March 1997

Monitoring Completed Navigation Projects Program

Burns Harbor, Indiana, Monitoring Study

Volume I: Overview of Approach and Results

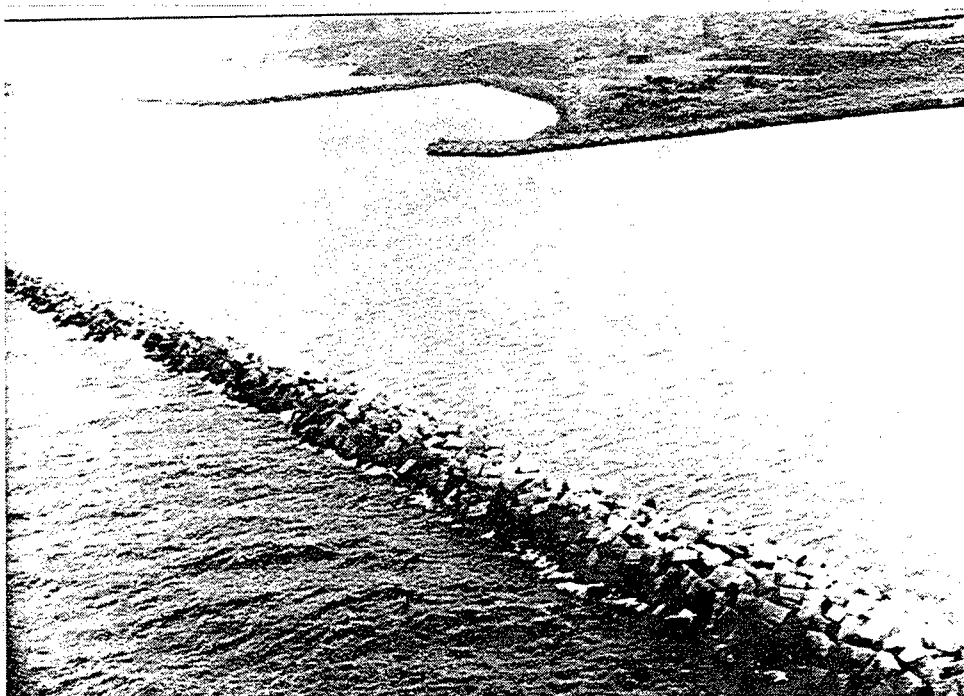
b. 1987 lakeside view

The parallelepiped, cut stone armor units, which range from 10 to 16 tons on the trunk and from 15 to 20 tons on the head, are typical for coastal structures in the Great Lakes, but the two-layer random placement was unusual at the time of its design. A high core design with laid-up placement of a single layer of armor is more typical. Burns Harbor was the first breakwater with this style of armor placement built in the Great Lakes (Figure 5).

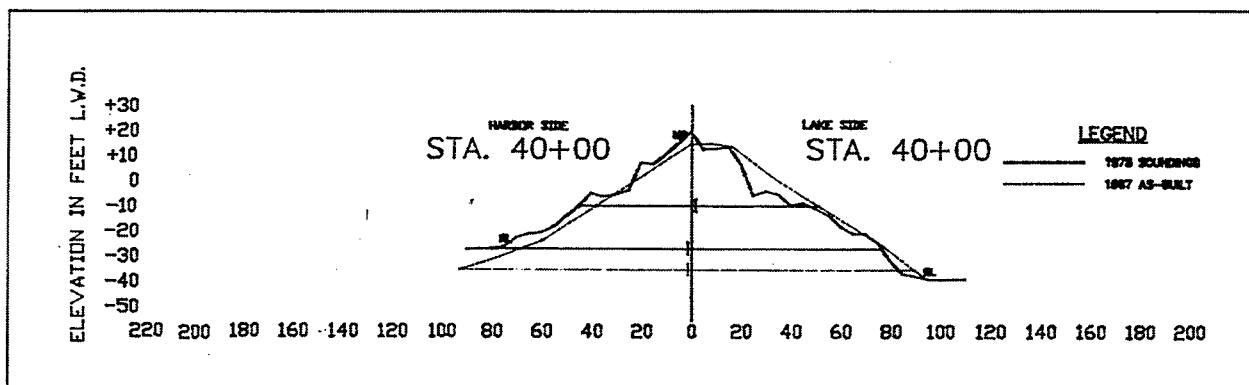
Figure 11. Typical as-built cross section

Construction started on the west end of the north breakwater and proceeded eastward; then the western arm was completed. Figure 8 represents the sequence of excavation and sand backfill operations based on contractor progress reports. Figures 9 and 10 are photographs of placement of the core stone and armor units, respectively, during construction. Stakes used for position control are visible. Figure 11 is a typical cross section from the as-built survey conducted by the construction contractor, and the same section obtained in a 1975 condition survey.

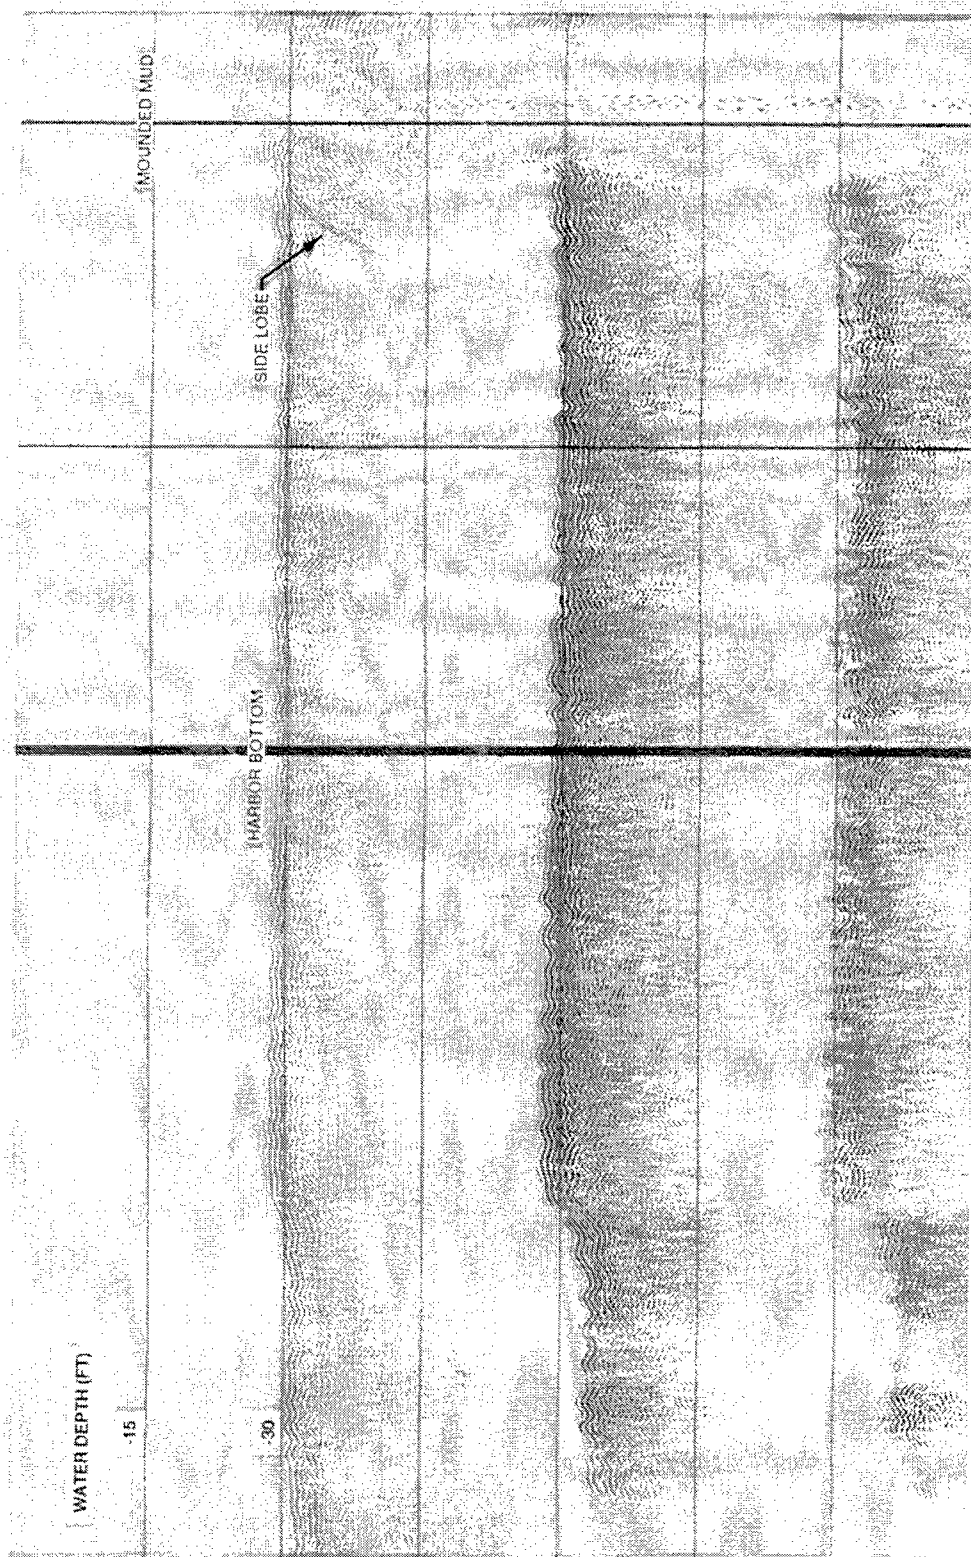
Figure 23. Subbottom sonar sonogram, line 35H

On the harborside, the SBS confirms the featureless bottom seen on the SSS sonogram. Figure 23 is the line 35H. The faint return from the soft clay as it slopes upward to about -20 ft is barely visible at the right end. Its shape is inconsistent with sedimentation due to material settling from above. There is no evidence of a distinct hard return as would be caused by armor stone below this slope. The curved reflection labeled "sidelobe" comes from strong reflections from the armor off to the side of the transducer as it approaches the structure.
